Kneller Hall

Heritage Assets Assessment *Draft v.2*

Prepared for LB of Richmond upon Thames

February 2019

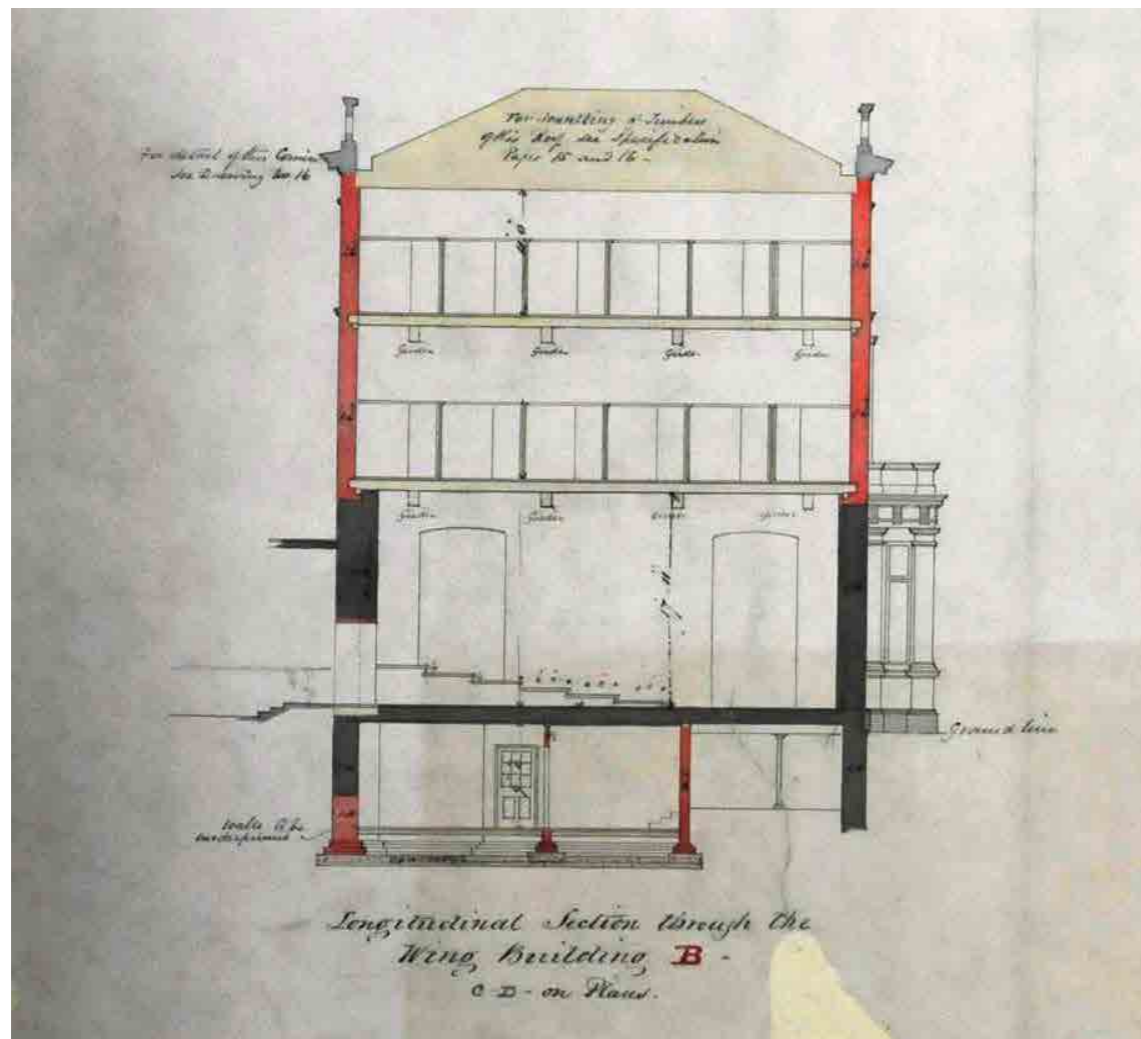
Based on the local geological map and a record borehole log from the British Geological Survey, the ground conditions comprise made ground over a layer of river terrace deposits comprising sands and gravels. Beneath this is London Clay. There is perched ground water on top of the impermeable London Clay within the river terrace sands and gravels. Based on archive drawings Kneller Hall is founded in the sands and gravels.

Figure 47: Section extract from archive drawings showing building foundations

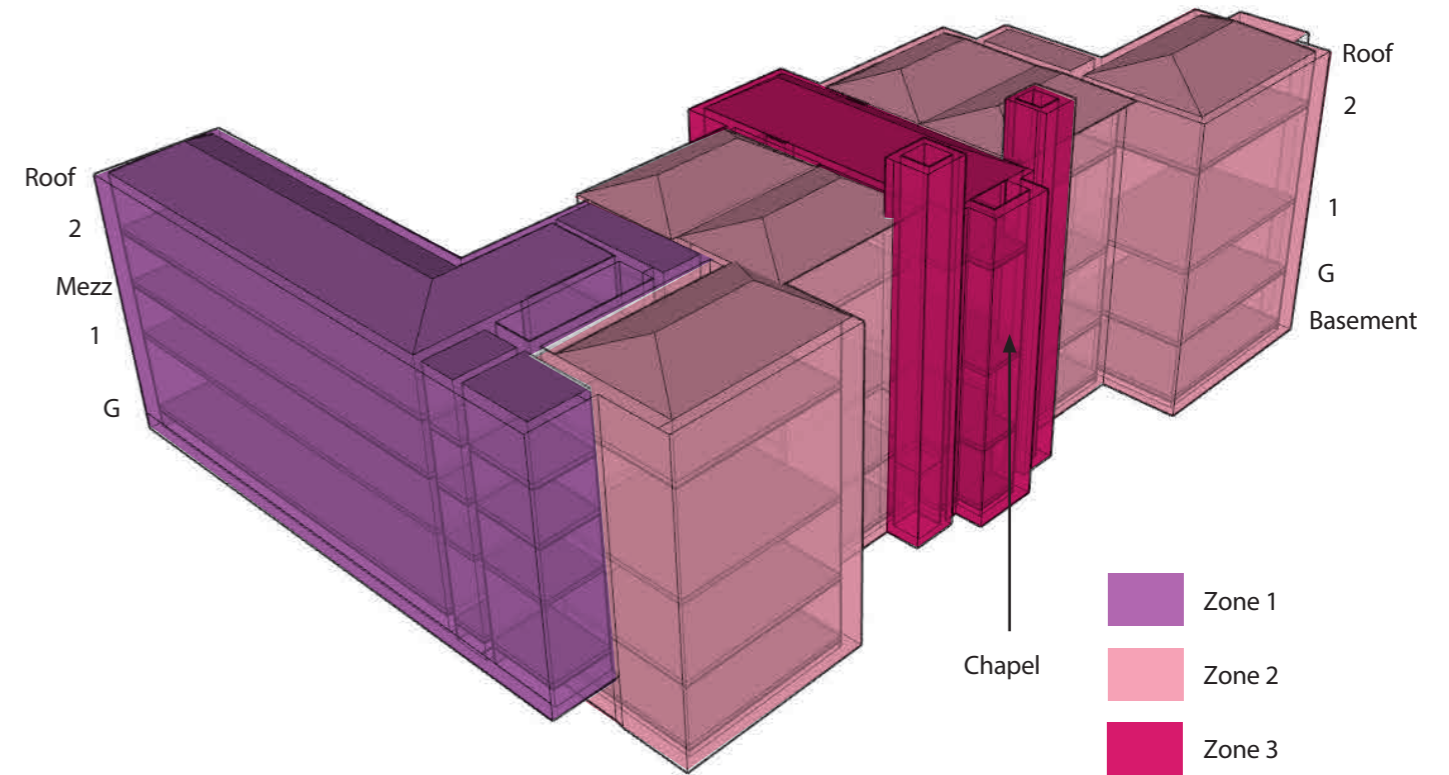
We visited site on 30 November 2018 to view Kneller Hall. As part of our overall study, we also visited the National Archives at Kew and retrieved some archive drawings of the building. We worked on the roof refurbishment of Kneller Hall in the 1980's and we have also retrieved our record drawings from our archives, which have provided us with an understanding of the roof structures. The knowledge gained from our visit and desk study has given us a general understanding of the building's overall structural arrangement and condition. In order to summarise this, the existing building has been divided into three zones as shown on the diagram to the right.

Figure 49: Key diagram showing building's zones

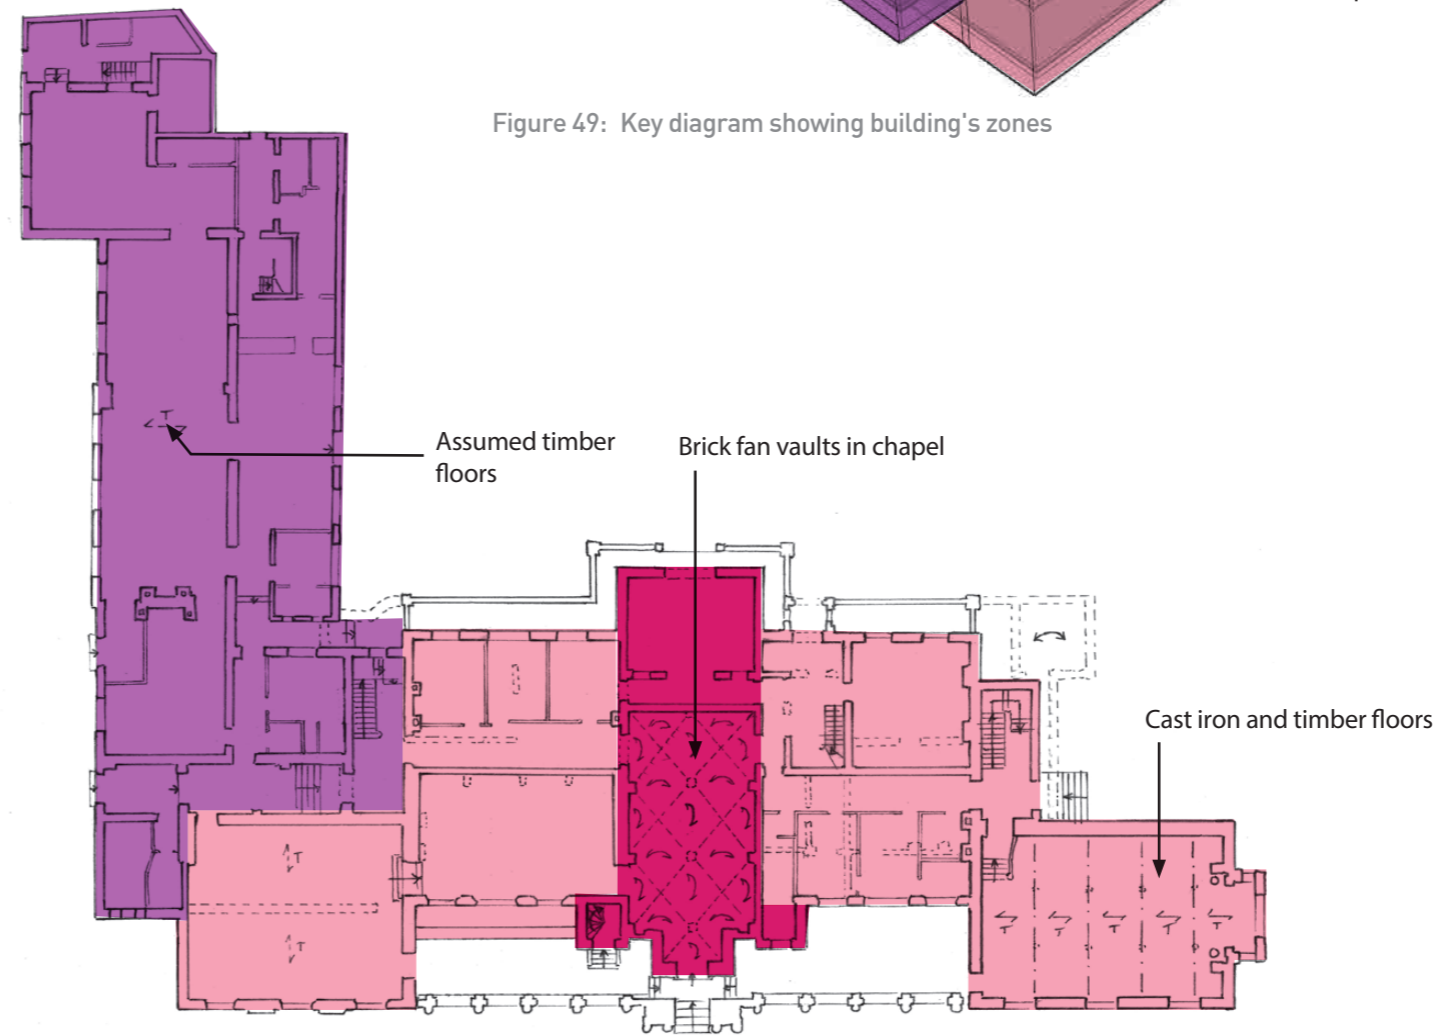
Figure 50: Ground floor structural arrangement

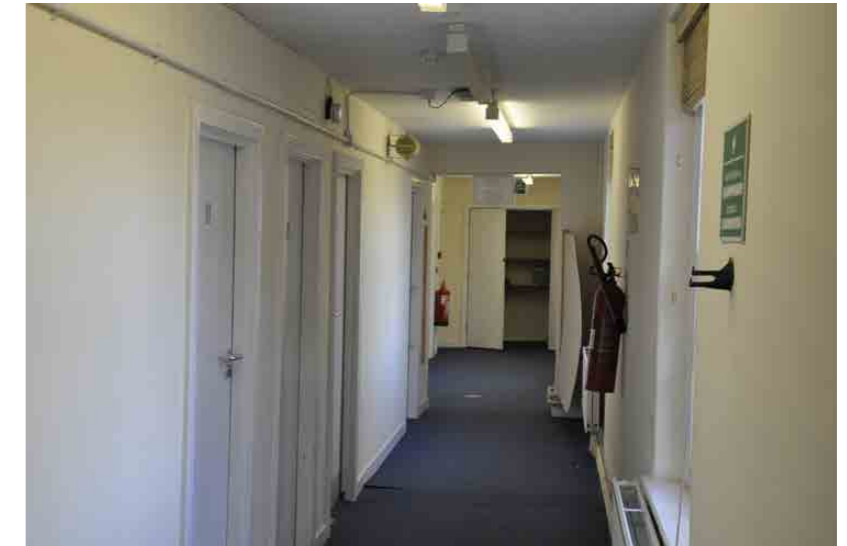
As described above, the mezzanine, second floor, and the north end of the first floor are not currently in use. In these areas, heavy blockwork partitions have been built up off the original timber floors. The timber floors in these areas are sagging considerably. In these areas, the blockwork partitions should be removed and opening up works should be carried out to confirm the condition of the timber floors. It is likely that significant repairs to the timber floors will be needed. Repairs are also likely to be needed to decayed timber joists where they are in contact with damp external masonry walls.

Figure 52: Partitions at second floor

The defects noted can generally be addressed as part of the next refurbishment. However depending on when this is carried out, it may be sensible to remove the partitions in the West Wing to mitigate further deterioration of the timber floors. It would also be sensible to address the faulty rainwater goods and below ground drainage to mitigate further deterioration.

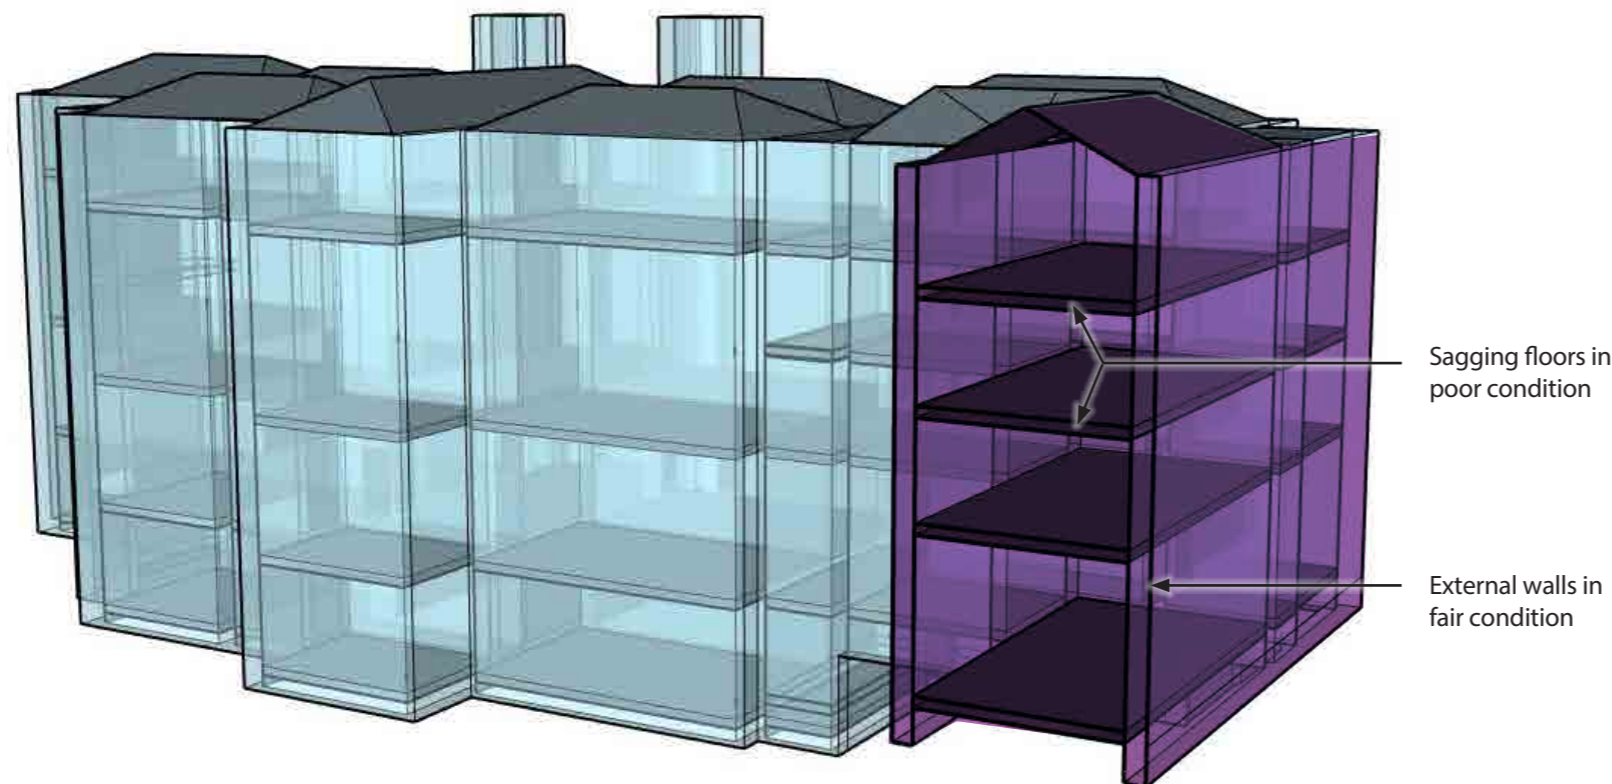
The external walls in the north-west corner of the wing are bulging. It is likely, based on our observations that the facing brickwork is delaminating from the rest of the wall behind. This is particularly noticeable on some of the window reveals where there is cracking in the brickwork. Elsewhere there are other local defects to the elevation that will need to be addressed.

Figure 51: Section diagram of Zone 1

We noted a number of areas where rainwater goods are blocked and these should be cleared to mitigate further water ingress into the structure of the building. The current issues with water ingress mean the timber roof members are likely to be decayed in these areas and repairs may be needed to these.

We have not accessed the main roof of the west wing. Repairs to the roof should be allowed for where rafters are in contact with damp external masonry at eaves.

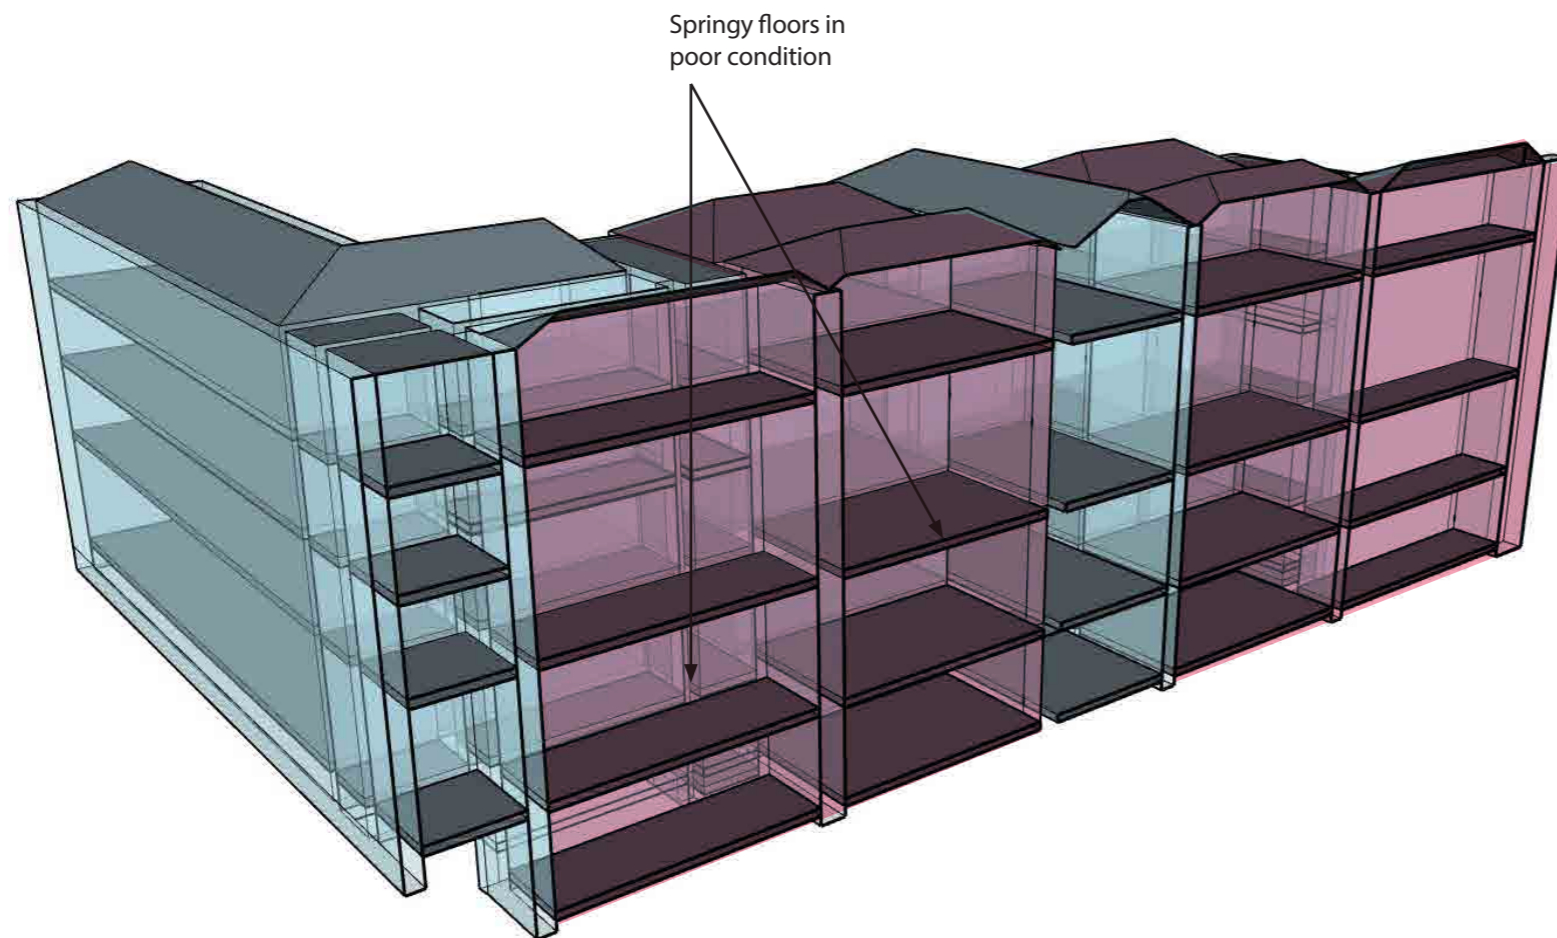
In this zone we noted several floors which are springy or sagging. This suggests there may be defects in the floors in these areas, and their condition should be investigated. At ground floor, room G23 is notably

springy. At first floor, rooms F22 and F23 are springy and sagging. In addition, the adjacent corridor is sloping toward the rooms to the north. Significant repairs should be allowed for to the floors in these areas as noted on drawings SK02 and SK03. Where timber joists are in contact with damp masonry walls, in particular at ground floor, repairs should be allowed for to address timber decay. We also noted cracking to the cantilever stone stair in the basement and repairs to this should be allowed for.

Figure 55: Section diagram through Zone 2

Although we have not accessed the roof, we noted some areas of water ingress at second floor ceiling level, which suggests water may be penetrating through the roof. Repairs to timber rafters are likely to be needed in these areas, particularly at eaves level where the rafters and wall plates are in contact with damp masonry walls.

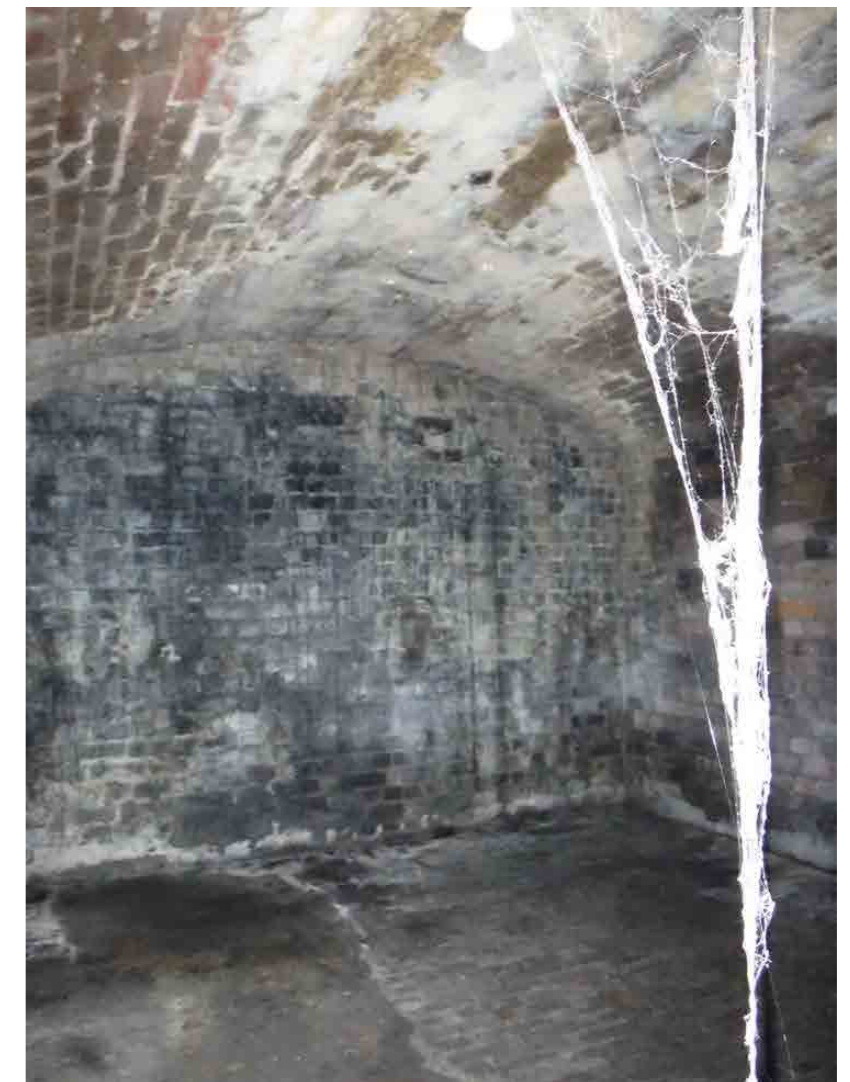
At basement level, the areas we accessed were generally in a reasonable condition, apart from the lightwells and basements which project beyond the footprint of the building. These areas are suffering from water ingress and damp. We noted standing water in the northern light-wells which suggests the below ground drainage system is defective. The below ground drainage in this area should be jetted and cleared and a CCTV survey should be carried out to confirm its condition. An allowance should be made for repairs to the below ground drainage in this area.

Figure 57: Damp basement

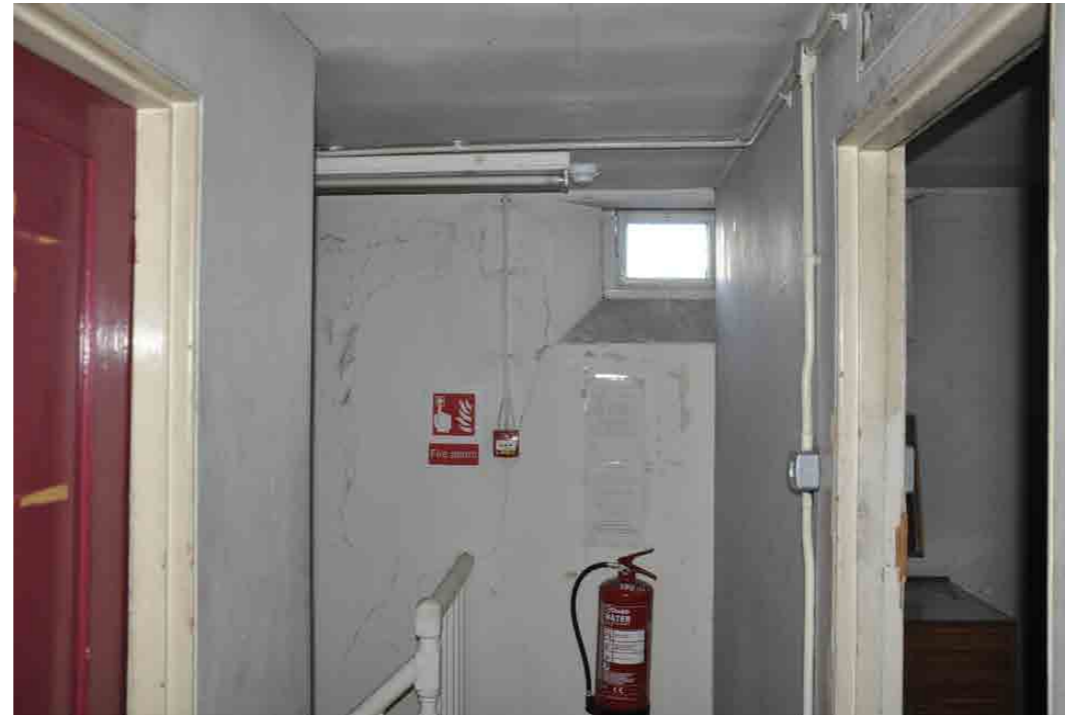
This area is generally in a good condition for its age and type of construction. We noted that the loft rooms (T01 to T04) showed signs of water ingress and minor cracking to plaster. Repairs to decayed roof timbers should be allowed for in this area similar to Zone 2.

Figure 58: Signs of water ingress in the loft

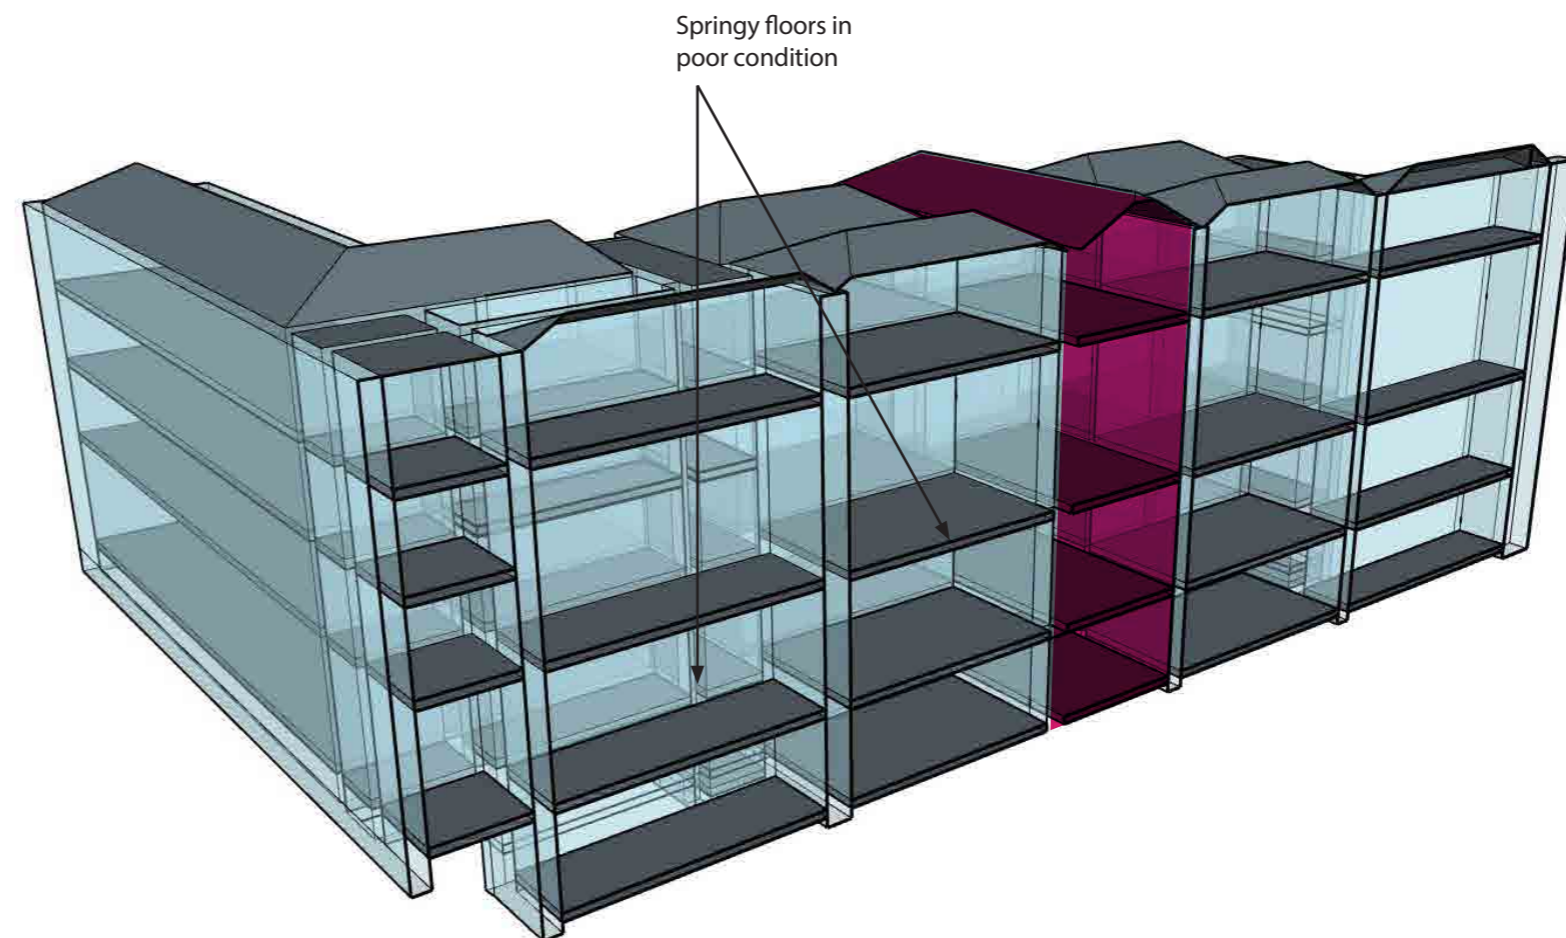
Figure 59: Section diagram through Zone 3

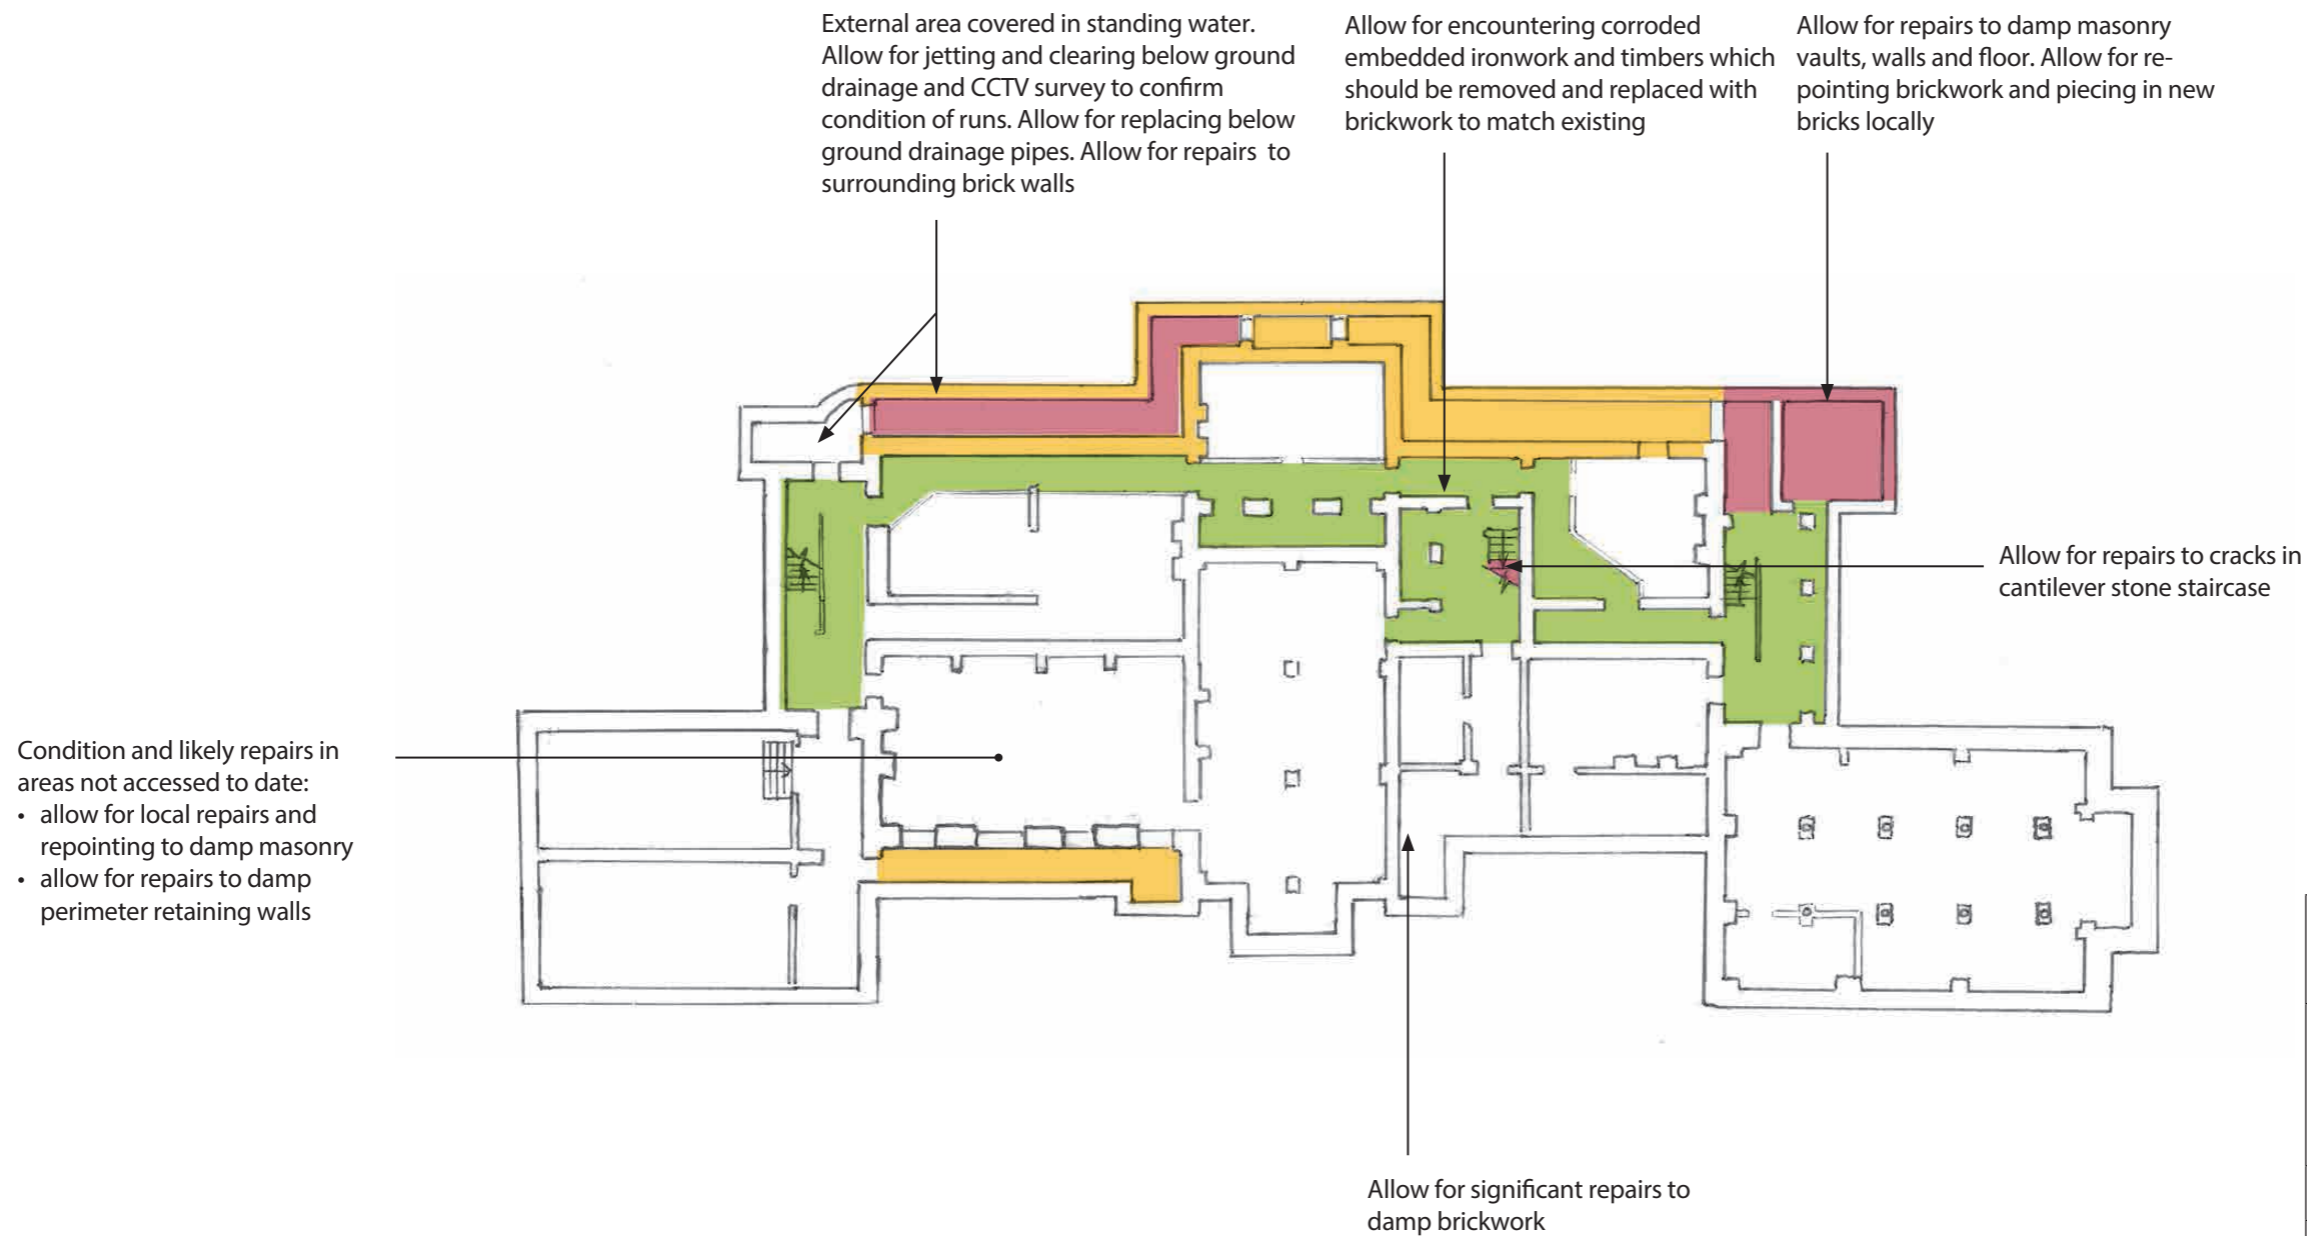
KNELLER HALL HERITAGE ASSETS ASSESSMENT	
SUMMARY OF STRUCTURAL CONDITION AND REPAIRS BASEMENT LEVEL	
1875/30 / SK01	
DECEMBER 2018	Alan Baxter

1. These drawings show an indication of likely repairs based on initial observations during our site visit. No physical opening up works have been carried out.
2. This drawing is to be read in conjunction with all other relevant engineers and architects drawings.
3. The repair allowances shown provide an indication of the likely works expected based on observations made during one site visit and available record information. The proposed extent of repairs needs to be defined in more detail as part of the next design stage when opening up works have been completed.

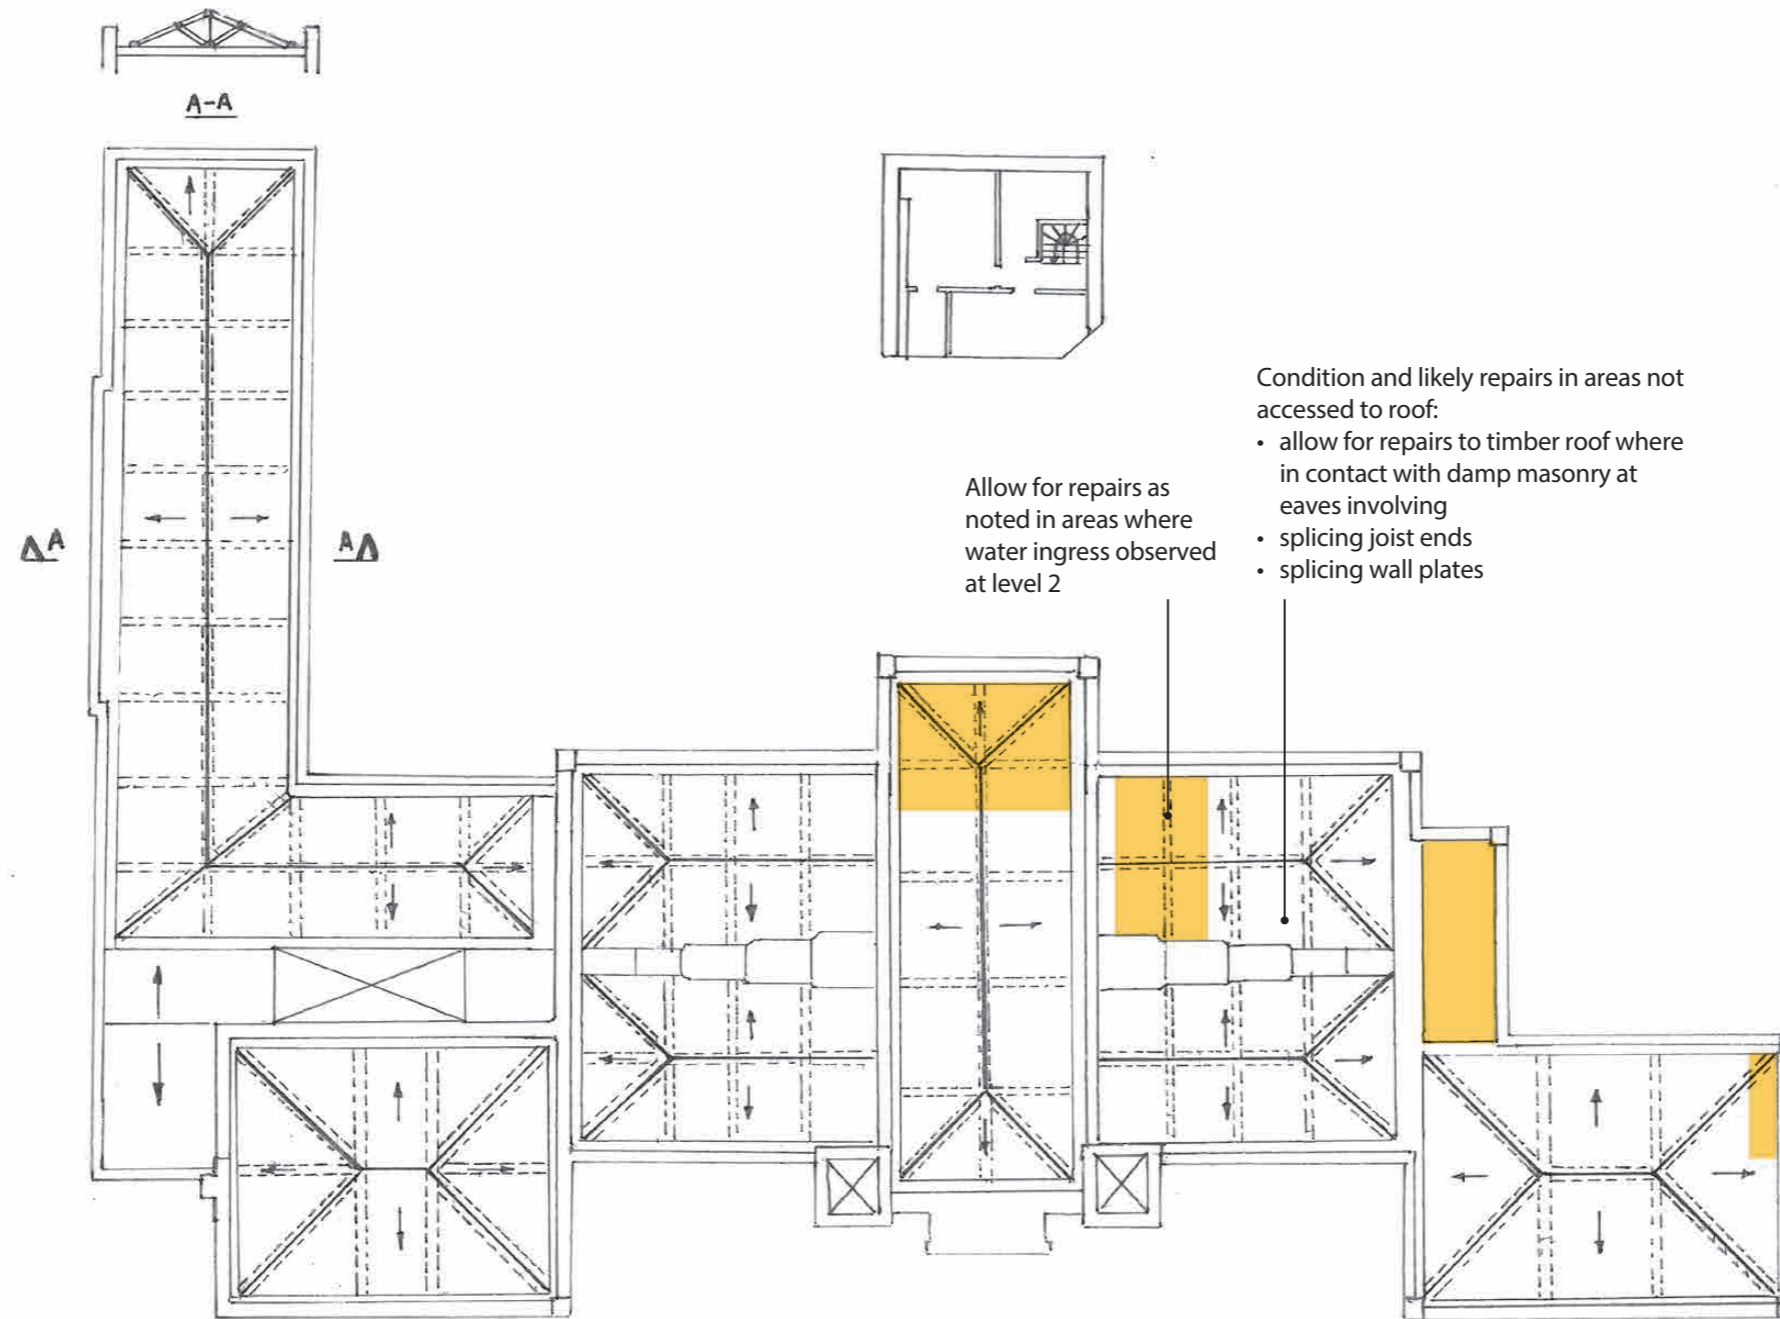
Allow for repairs as noted in areas where water ingress observed at level 2
